## DETECTING OFF-RATIO PROBLEMS

## Morning Test Procedure for Fusion Gun

## Removing Cured Adhesive from Fusion Gun Air Passages

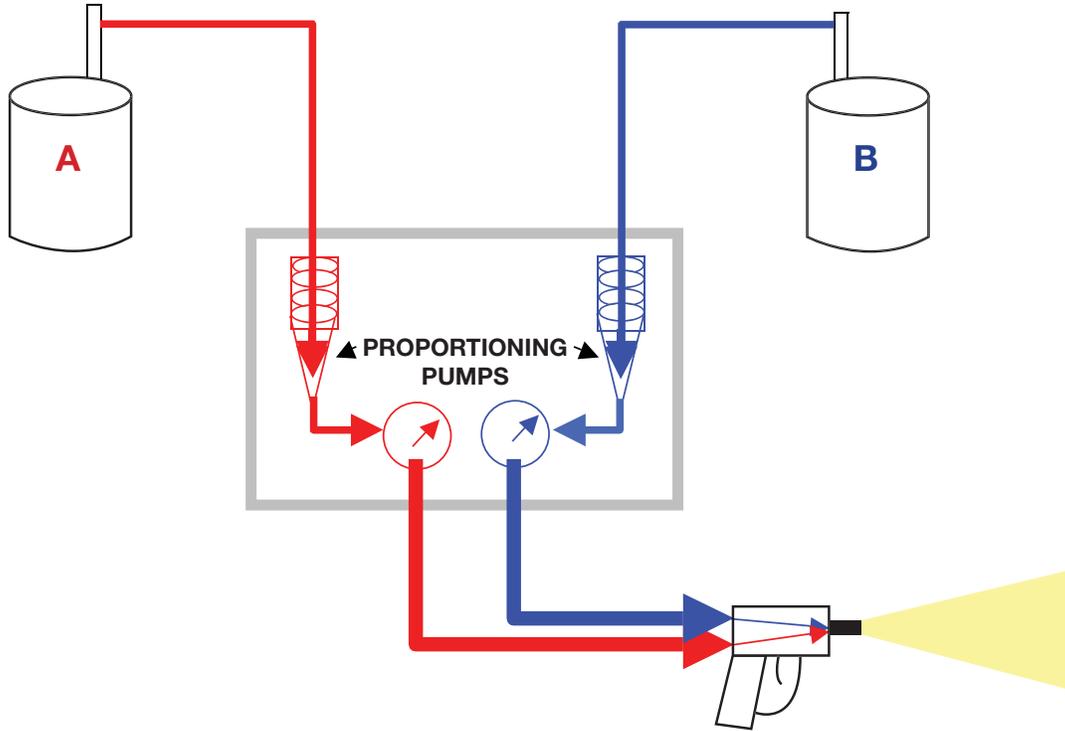
### “A” SIDE RICH

FAST 100-LV will have little rise and be dark in color. Flexible FAST will be light blue in color. Both may be brittle, crunchy or friable.

### “B” SIDE RICH

FAST 100-LV will be light in color. Flexible FAST will be dark blue in color. Both will be soft and spongy.

**The problem will be on the “B” side of the machine.**

If the “B” gauge reads high, the problem is most likely in the spray gun on the “B” side. Check for a plugged screen; check valve, mixing chamber, and passage. It is also possible that the “B” material is cold.

If the “B” gauge reads low, the pump is starving on the “B” side. Check the transfer pump, the supply valve and the supply screen. It is also possible that the pump is starving because of extremely cold material.

**The problem will be on the “A” side of the machine.**

If the “A” gauge reads high, the problem is most likely in the spray gun on the “A” side. Check for a plugged screen; check valve, mixing chamber or passage.

If the “A” gauge reads low, the pump is starving on the “A” side. Check the transfer pump, the supply valve or the supply screen.

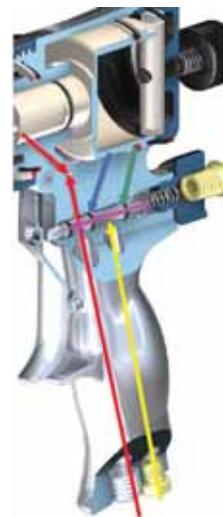
If gun fills with foam (crossover), you must clean all the air passages with a drill bit by hand. The passages in the handle of the gun require a 1/8" x 8" drill bit. (DO NOT USE A POWER DRILL!)

With the gun completely disassembled, clean the passages as follows:

1. The purge air passage must be cleaned from two directions, from the front of the piston cylinder down and from the bottom of the handle up.
2. The "Piston Back" passage from the cylinder down.
3. The "Piston Forward" passage from the cylinder down.
4. The trigger air from the bottom of the handle up.
5. The trigger assembly has a passage that runs between the two small holes. All three must be clean in order for the gun to function.
